DAMAGE PROFILES IN SILICON AND THEIR
IMPACT ON DEVICE RELIABILITY

Guenter H. Schwuttke

International Business Machines Corporation

TECHNICAL REPORT No. 1
January 1973

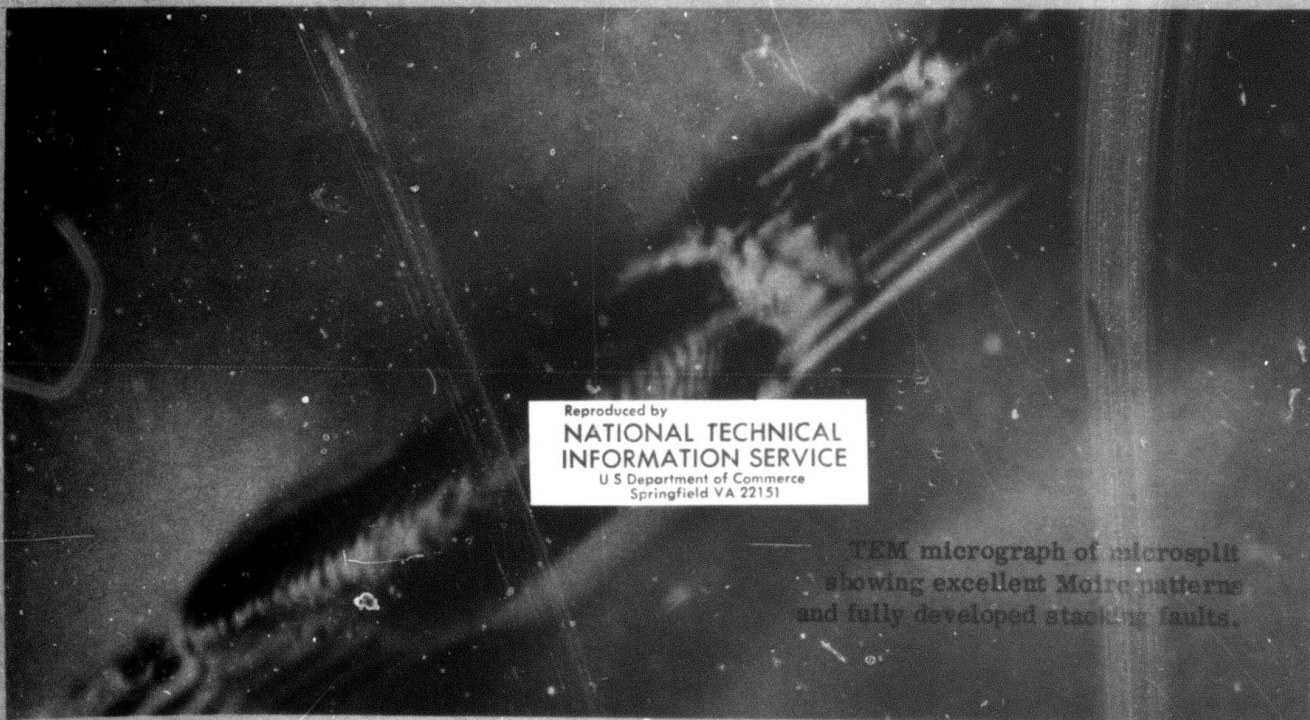
TEM micrograph of microsplit
showing excellent Moire patterns
and fully developed stacking faults.

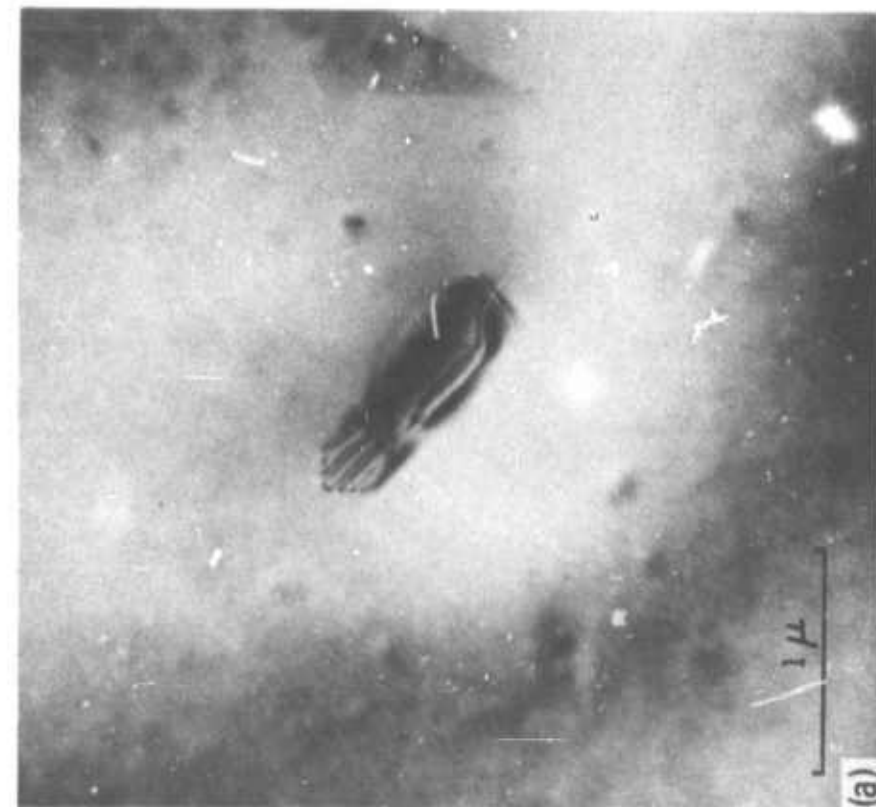
Fig. 6. TEM micrographs of microsplit. (a) Birth of stacking fault at one end. (b) Stacking faults at both ends.

An interesting series of micrographs is displayed in Figs. 6a, b. Evidently, the shear stresses displayed in the preceding micrographs at the fault ends are large enough in this case to generate stacking faults. Figure 6a shows the birth of a stacking fault due to stress relief at one end of the linear defect while Fig. 6b shows well developed stacking faults at both ends of the defect.

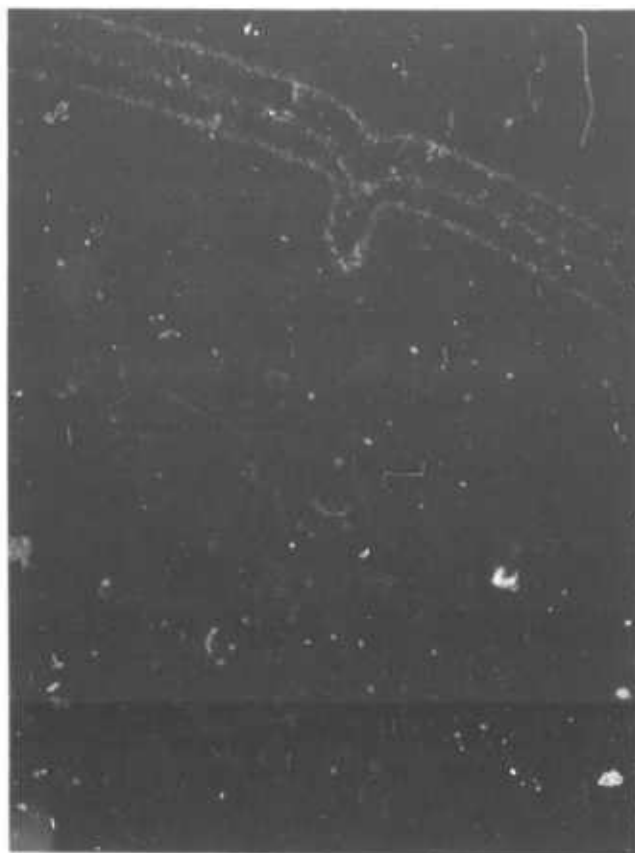
Fig. 9. Optical micrograph of bad device after stripping and Sirtl etching. Note linear defects in $\langle 110 \rangle$ orientation.

Sirtl etching was applied to the device surface after stripping the Al and the SiO_2 . Occasionally etching was successful in delineating the linear faults. Most of the time the etch patterns did not reveal a clear-cut difference between a good and a bad device. Etching depends very much on the fault size and seems to work quite well for faults in the micron size. An example is shown in Fig. 9 which pictures the silicon surface of a bad device after stripping and Sirtl etching. Linear defects are clearly visible in $\langle 110 \rangle$ directions. Scanning electron micrographs of such defects are given in Figs. 10a, b. Figure 10a shows a longitudinal view of the defect. The defect looks like an open cut or split in the lattice and supplements the transmission electron micrograph information. A fault like the one displayed in Fig. 10a obviously must introduce high stresses into the lattice, particularly at the fault ends. Such lattice splits have a tendency to close in order to minimize their elastic tip stresses. Most of the time more or less complete closure takes place in agreement with the observation of Moire patterns in the transmission electron

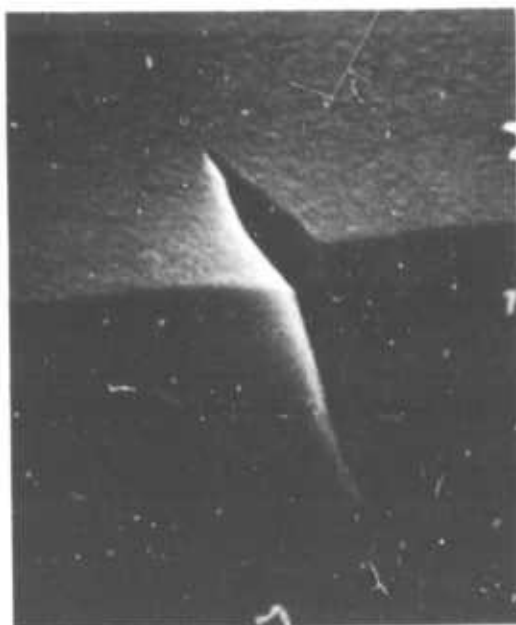
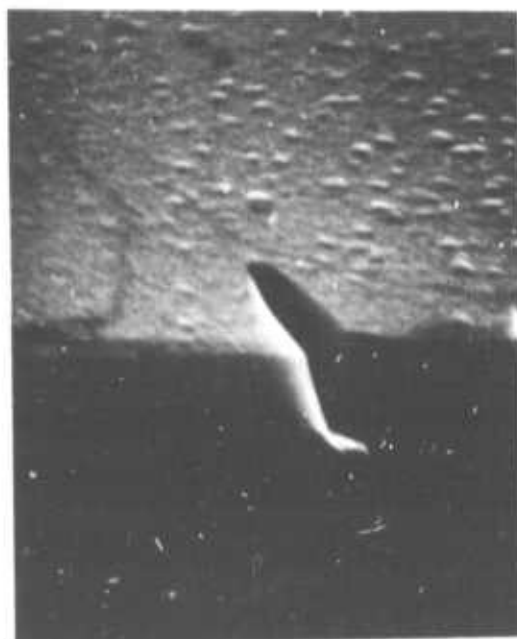
Fig. 10. SEM micrographs of split. (a) From etch figures corresponding to Fig. 9. (b) Cross section of two different splits.

micrographs. A cross-sectional view of two microsplits after etching is shown in the SEM photomicrograph of Fig. 10b. The cross-sections show that such faults penetrate to different depths and are not confined to cleavage planes. This observation supports partial split experiments made on germanium.⁹
